SYMMETRY PARK: HEDGEROW BNG CHANGE DETECTION

Greggs are in the process of building a new National Distribution Centre at Symmetry Park, Kettering.

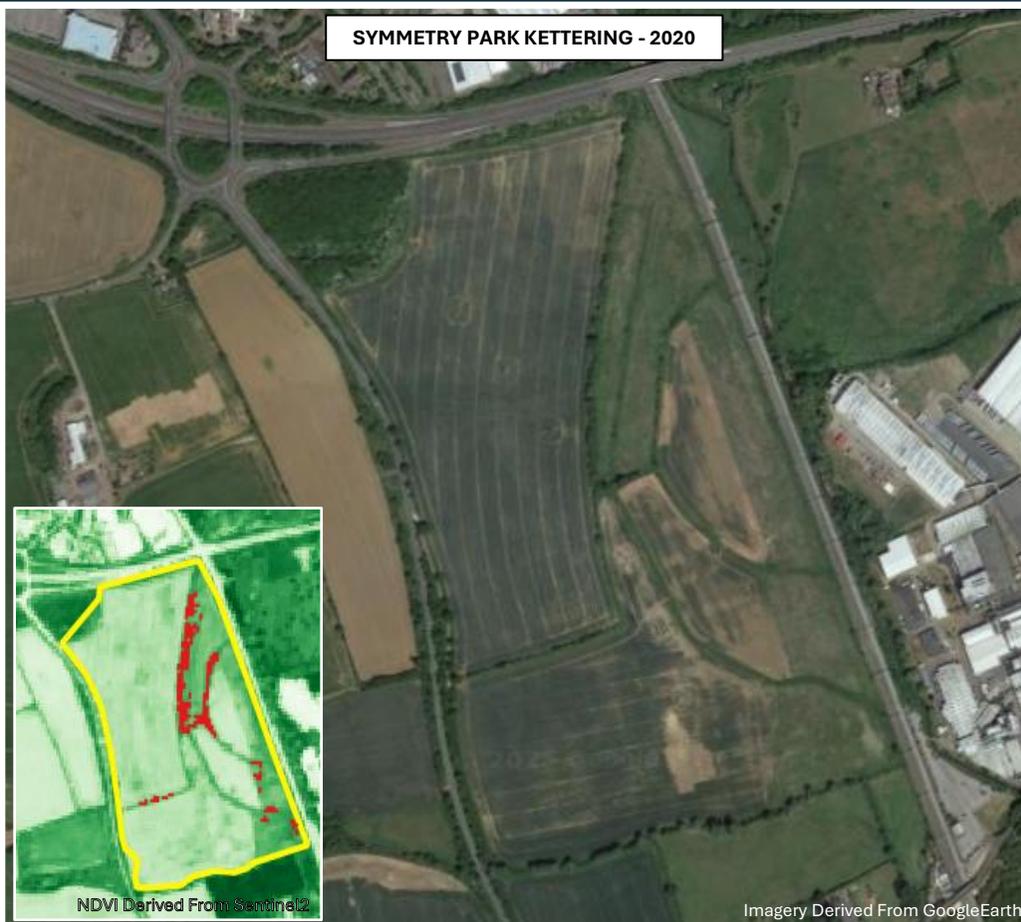
Area: **~2.4 ha**

Linear: **~950m**

Area of Woodland / Hedgerows that have been removed during construction of Symmetry Park

North: **~300m**

East: **~330m**

South: **~450m**

West: **~300m**

Approximate proximity of removed hedgerow centre of mass to retained woodland at Symmetry Park

Areas exhibiting a significant negative NDVI change were classified as vegetation removal and spatially intersected with mapped hedgerow corridors to estimate the likely extent and length of hedgerow loss, providing a consistent, site-wide screening assessment aligned with BNG principles.

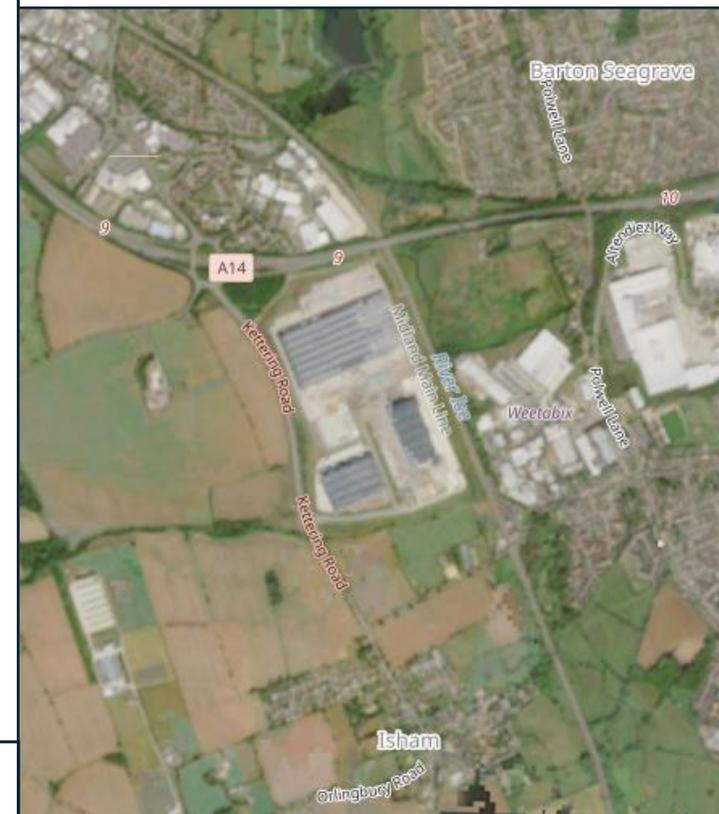
SOURCE DATA

Copernicus Programme Sentinel-2 Level-2A multispectral imagery
(accessed via Copernicus Browser)

Pre-construction image: **18 September 2020**
 Current-construction image: **5 January 2026**
 Spatial resolution: **10 m** (Bands B04 – Red, B08 – Near-Infrared)
 Processing level: **Bottom-of-atmosphere reflectance (L2A)**

Derived datasets (created in QGIS)
 NDVI rasters for 2020 and 2026
 NDVI difference raster (dNDVI) identifying sustained vegetation loss
 Polygonised vegetation-loss layer used for area and length calculations
